This document details independently researched real fire case studies across the world, proving the excellent in-use performance of Insurer Certified PIR panel systems

The Performance of PIR Core Sandwich Panels in Real Fire Situations

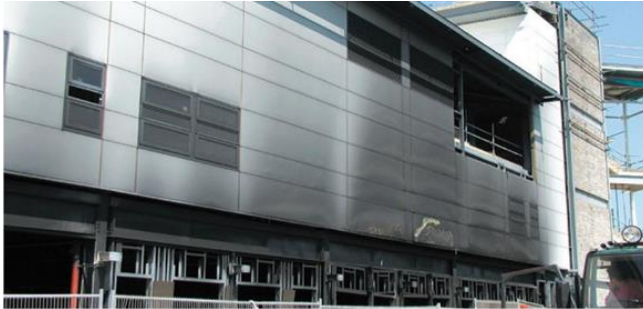
Photograph 1 shows the fire area

The heat generated by the fire was significant, as evidenced by cracking of the concrete floor above the fire and the distortion of steel beams that had been protected by a fire resisting intumescent coating.

The fire service found light smoke but no fire spread on the upper floors of the building. They also reported that although the joint between the floor and first floor walls had not been fire stopped there was no fire spread within the PIR core material.

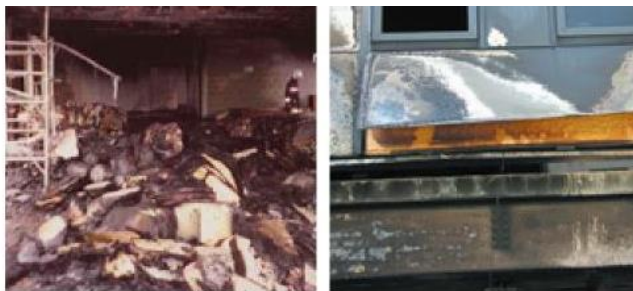
Photograph 2 shows where the flame damaged outer skin of the bottom panel has been lifted to inspect the slight charring of PIR core beneath

In spite of a very severe fire at ground level (sufficient to damage the concrete floors and distort fire protected steel beams) the cores of the insulated panels:

- Did not ignite; and
- Did not promote fire spread

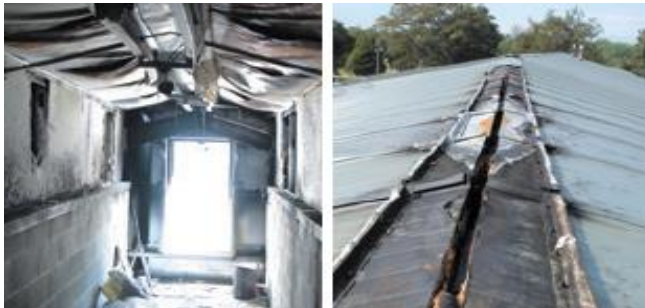
Photographs 2 & 3 show the area where the fire started, and the apex of the roof respectively) (with some discolouration in the area subject to direct flame attack, but no evidence of fire spread)

Photograph 2 shows the empty drum thought to have contained the roof sealant, and holes made in the partition system by the fire service to check that the fire had been completely extinguished.

The plastic and glass components of the fire alarm and light fittings had shattered/melted and although delamination of the inner skin of the insulated panels occurred, the core and outer skin remained undistorted. The deformation of the purlins immediately above the seat of the fire indicated that this was a very hot fire.

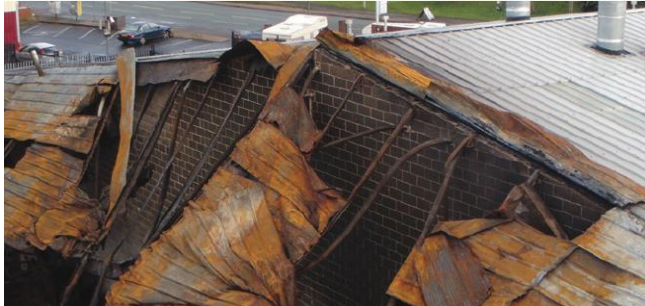
Photograph 1 shows the aftermath of the fire and the performance of the compartment wall

The aftermath of the fire demonstrated that the fire compartment wall performed its intended function in preventing fire spread to the business next door, which was able to continue trading. In this case, the PIR cored insulated panel insulation had been continuous over the top of the compartment wall.

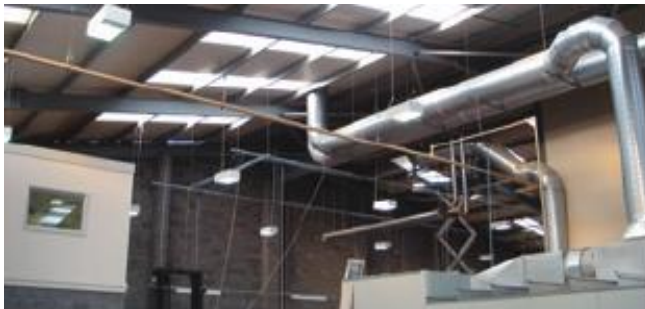
Photograph 2 shows the interior of the adjacent business to be unaffected by the fire

An examination, carried out on the panel interface at the head of the wall, showed that the PIR core had charred to form a stable and effective seal between the steel skins of the sandwich panel to prevent fire transmission to the protected side of the wall

The fire was sufficiently intense to have subjected the party wall between the adjacent tenancies to a level of exposure equivalent to at least 60 minutes in a standard fire resistance test. The charring exhibited by the PIR core material indicated the formation of a sufficiently stable char within the panel to provide an effective fire stop between the steel skins of the cladding panels at the head of the compartment party wall.

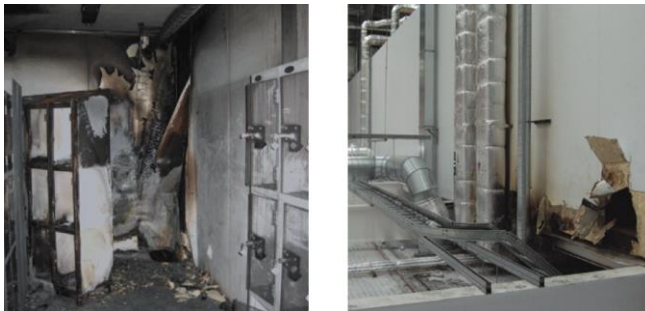
Photographs 2 & 3 show the cut-open wall panels indicating no fire propagation

During their operations the fire service cut open the wall panels (as above). This is standard practice to ensure that there is no continuing burning within the construction or voids. It was evident that where the fire service had opened up the panels there was evidence of only very limited charring of the PIR core with no suggestion of any fire propagation within the core material.

- The sections of the wall panels that were subject to direct contact with the fire suffered surface distortion and superficial charring of the PIR core material. However, there was no evidence of fire propagation within the core material.
- Whilst there was some fire spread beyond the room of fire origin this was via the void in the timber floor. The PIR panels provided an effective barrier to fire spread, i.e. there was no fire spread through the panels into adjacent areas.

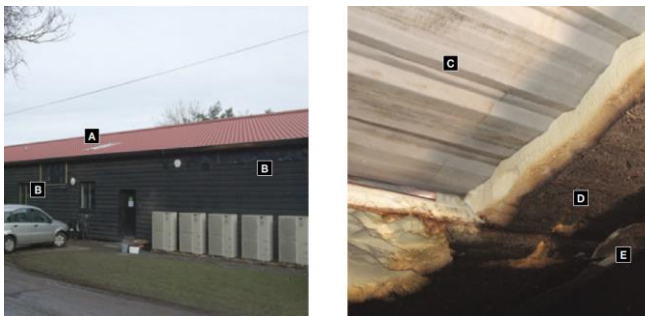
Photographs 1 & 2 shows:

*A Vent cut in roof by fire service B Vents cut in wall by fire service C: Temporary roof covering hole in roof
D: PIR core showing delamination lower surface and extent of through-thickness charring E: Cut edge of lower steel skin of sandwich panel*

On locating the area of the fire the attending fire service cut a hole through the roof construction directly above the fire and in the location of the damage shown in the above image to ventilate the area. The images show the hole which was cut (which has been temporarily re-covered). The effect of the heat of the fire on the PIR core can be seen showing delamination of the exposed steel skin of the sandwich panel from the core, the formation of a carbon char layer and unaffected material at greater depth in the section which has been insulated from the fire.

Notably, the fire spread in the building was constrained to the mezzanine plant area and the combustible materials therein. Outside of this area, roof timbers were scorched, but not charred, indicating that temperatures were reduced to less than 450°C and PIR roof panels were not delaminated indicating clearly that the fire had not been propagated by the PIR core of the sandwich panel.

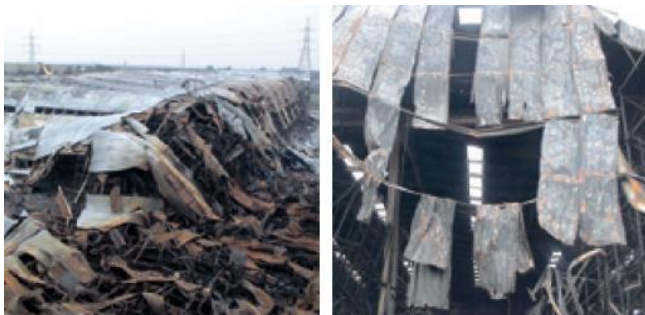
Despite the duration and severity of the fire, significant areas of insulated cladding panels remained with only limited damage to core material indicating that the PIR core material did not promote fire spread.

Photographs 1 & 2 show the collapsed south-end of the building and roof-sheeting hanging from severely damaged steelwork

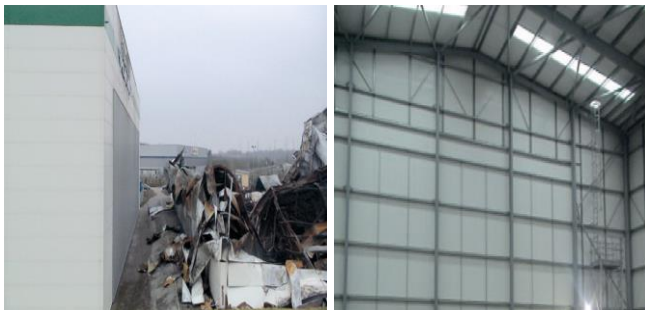
Photographs 3 & 4 show the undamaged adjacent building (exterior and interior respectively)

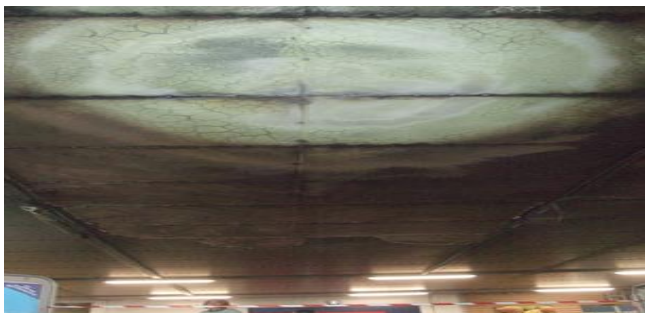
Photograph 2 shows the flame impact on the soffit lining

The PIR cored sandwich panels were subjected to a period of fire exposure lasting at least 8 minutes and resulting in a period of sustained flame impingement. The sandwich panels exposed to these conditions sustained damage in terms of removal of the paint coating together with distortion and delamination of the exposed steel skin of the panels away from the PIR core, but the flames did not penetrate the structure, thus maintaining the safety of shoppers and staff.
