# Real Fire Case Studies

# THE PERFORMANCE OF PIR CORE SANDWICH PANELS IN REAL FIRE SITUATIONS

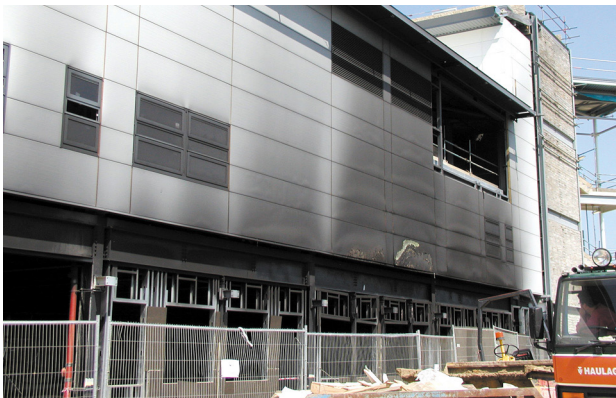
The heat generated by the fire was significant, as evidenced by cracking of the concrete floor above the fire and the distortion of steel beams that had been protected by a fire resisting intumescent coating.

*Photograph 1 shows the fire area.*

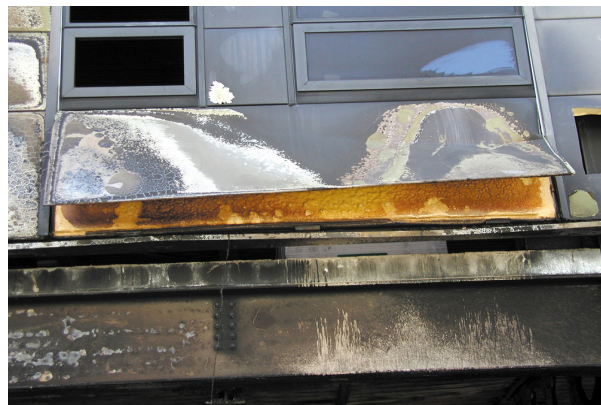
The fire service found light smoke but no fire spread on the upper floors of the building. They also reported that although the joint between the floor and first floor walls had not been fire stopped there was no fire spread within the PIR core material.

*Photograph 2 shows where the flame damaged outer skin of the bottom panel has been lifted to inspect the slight charring of PIR core beneath.*

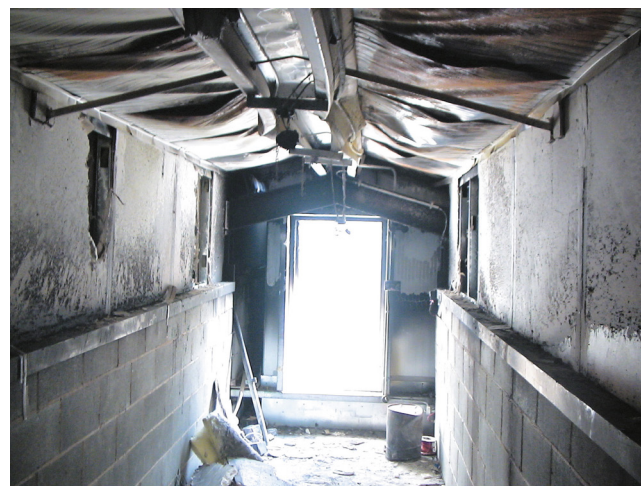
Photograph 2 shows the empty drum thought to have contained the roof sealant, and holes made in the partition system by the fire service to check that the fire had been completely extinguished.

The plastic and glass components of the fire alarm and light fittings had shattered/melted and although delamination of the inner skin of the insulated panels occurred, the core and outer skin remained undistorted. The deformation of the purlins immediately above the seat of the fire indicated that this was a very hot fire.

*Photograph 2 & 3 show the area where the fire started and the apex of the roof respectively (with some discolouration in the area subject to direct flame attack but no evidence of fire spread).*

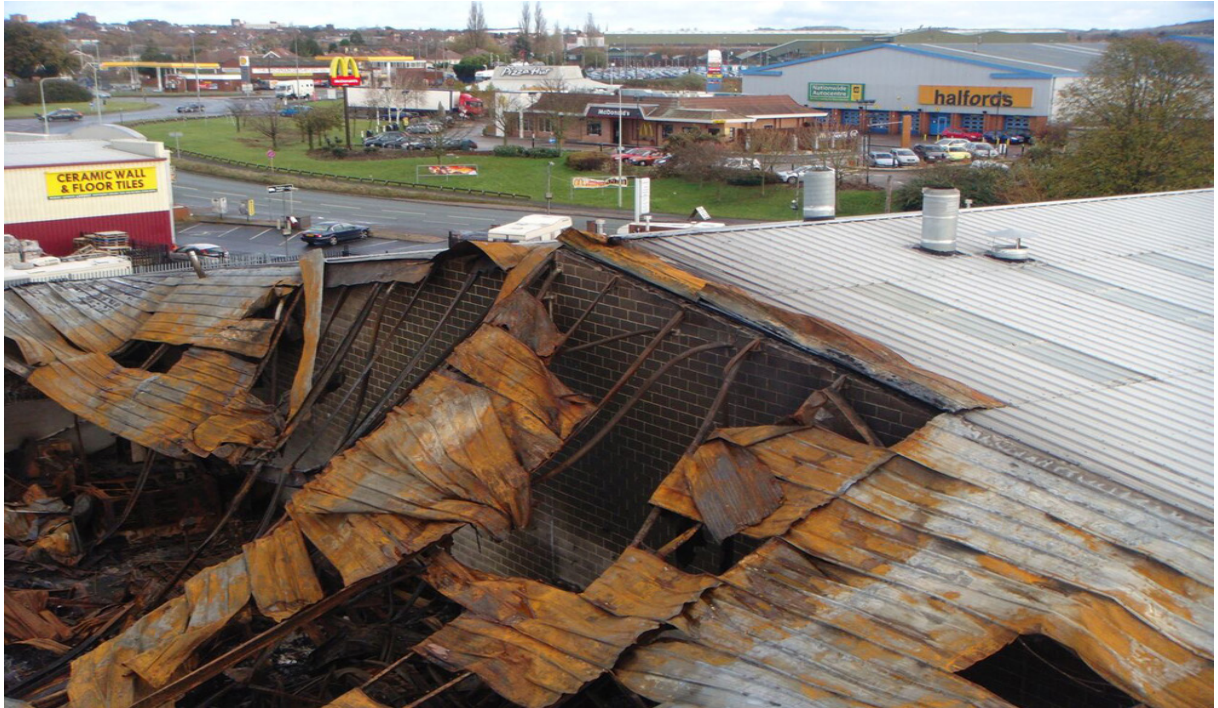
The aftermath of the fire demonstrated that the fire compartment wall performed its intended function in preventing fire spread to the business next door, which was able to continue trading. In this case, the PIR cored insulated panel insulation had been continuous over the top of the compartment wall.

An examination, carried out on the panel interface at the head of the wall, showed that the PIR core had charred to form a stable and effective seal between the steel skins of the sandwich panel to prevent fire transmission to the protected side of the wall

*Photograph 1 shows the aftermath of the fire and the performance of the compartment wall.*

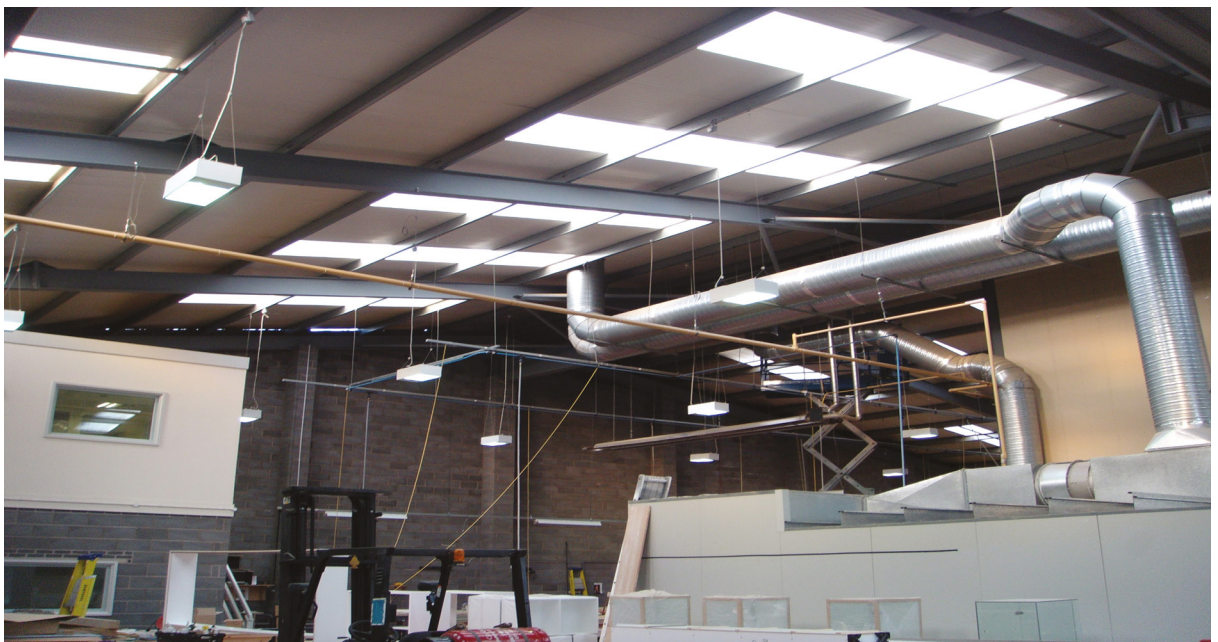
*Photograph 2 shows the interior of the adjacent business to be unaffected by the fire.*

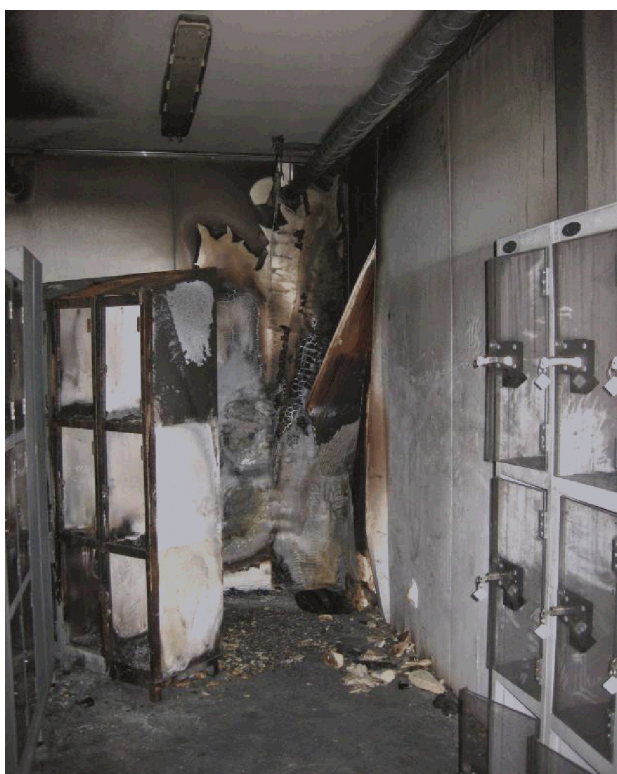
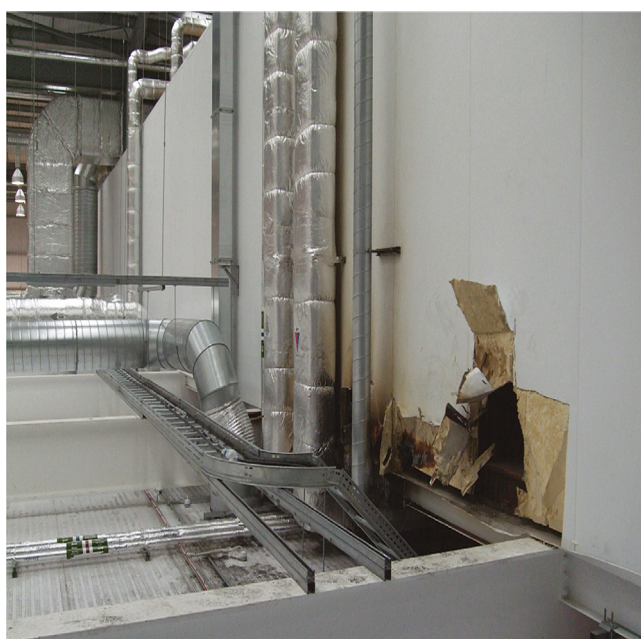
During their operations the fire service cut open the wall panels (as above). This is standard practice to ensure that there is no continuing burning within the construction or voids. It was evident that where the fire service had opened up the panels there was evidence of only very limited charring of the PIR core with no suggestion of any fire propagation within the core material.

- The sections of the wall panels that were subject to direct contact with the fire suffered surface distortion and superficial charring of the PIR core material. However, there was no evidence of fire propagation within the core material.
- Whilst there was some fire spread beyond the room of the fire origin, this was via the void in the timber floor. The PIR panels provided an effective barrier to fire spread, ie. there was no fire spread through the panels into adjacent areas.

*The photograph to the right shows the undamaged exterior of the building. Photographs 2 & 3 (below) show the cut-open wall panels indicating no fire propagation.*

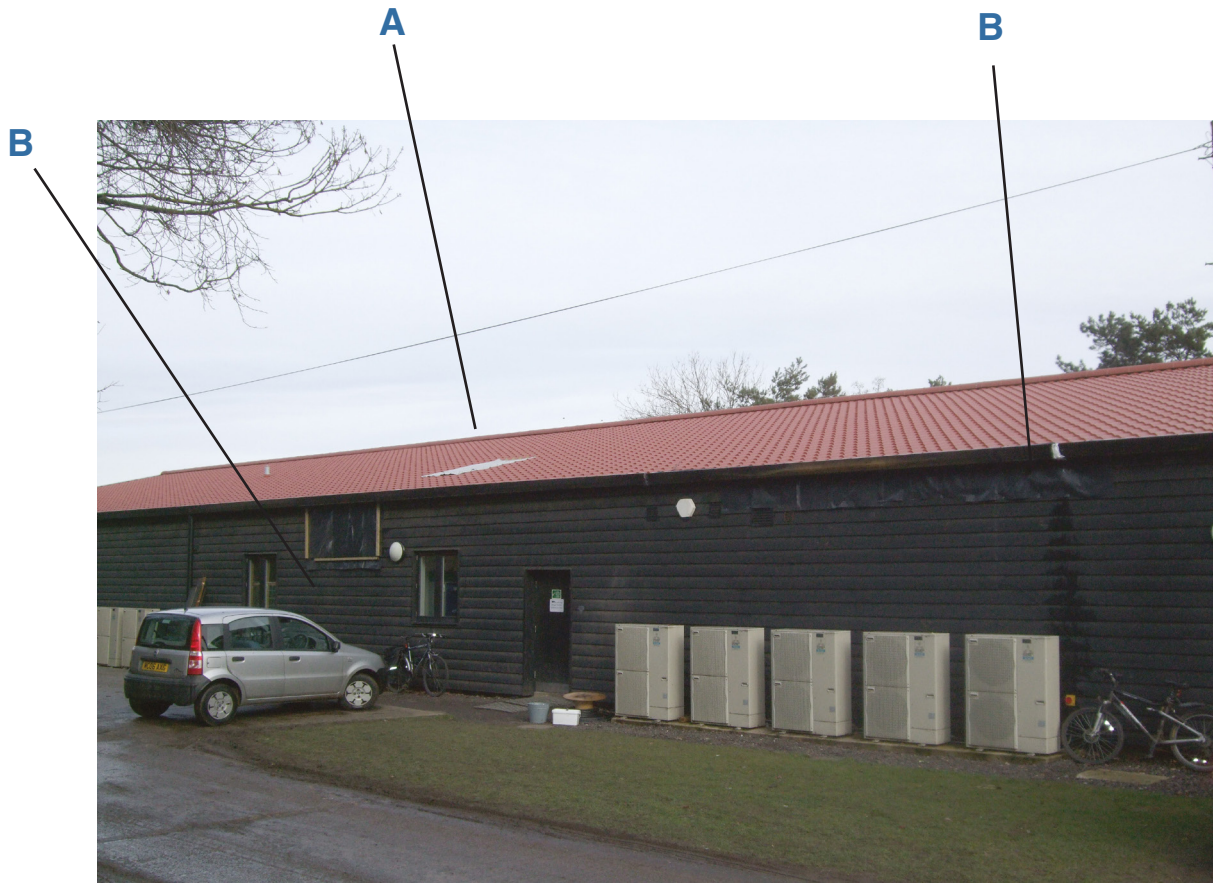
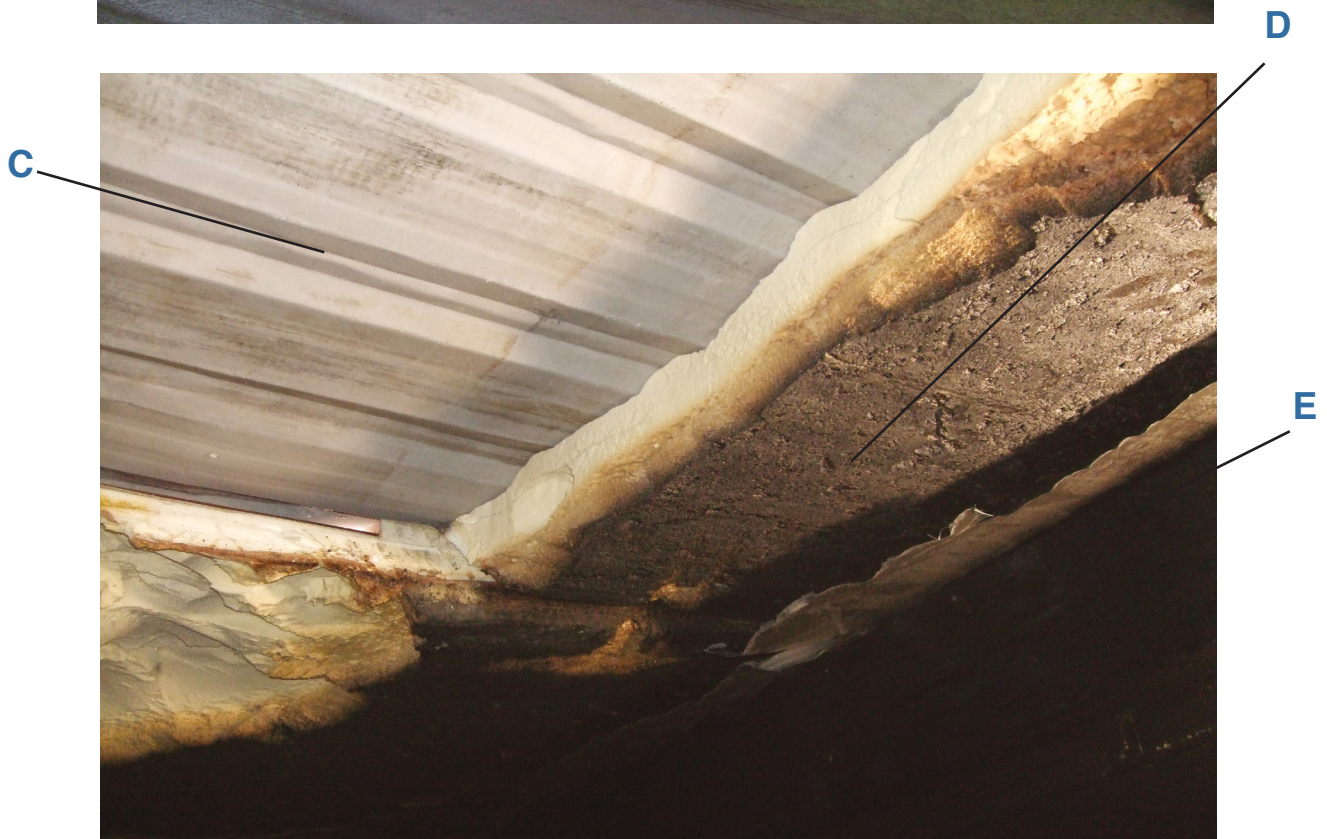
*Photograph 1 & 2 shows:*

On locating the area of the fire the attending fire service cut a hole through the roof construction directly above the fire and in the location of the damage shown in the above image to ventilate the area. The images show the hole which was cut (which has been temporarily re-covered). The effect of the heat of the fire on the PIR core can be seen showing delamination of the exposed steel skin of the sandwich panel from the core, the formation of a carbon char layer and unaffected material at greater depth in the section which has been insulated from the fire.

Notably, the fire spread in the building was constrained to the mezzanine plant area and the combustible materials therein. Outside of this area, roof timbers were scorched, but not charred, indicating that temperatures were reduced to less than 450°C and PIR roof panels were not delaminated indicating clearly that the fire had not been propagated by the PIR core of the sandwich panel.

- A. Vent cut in roof by fire service*
- B. Vents cut in wall by fire service*
- C. Temporary roof covering hole in roof*
- D. PIR core showing delamination lower surface and extent of through-thickness charring*
- E. Cut edge of lower steel skin of sandwich panel*

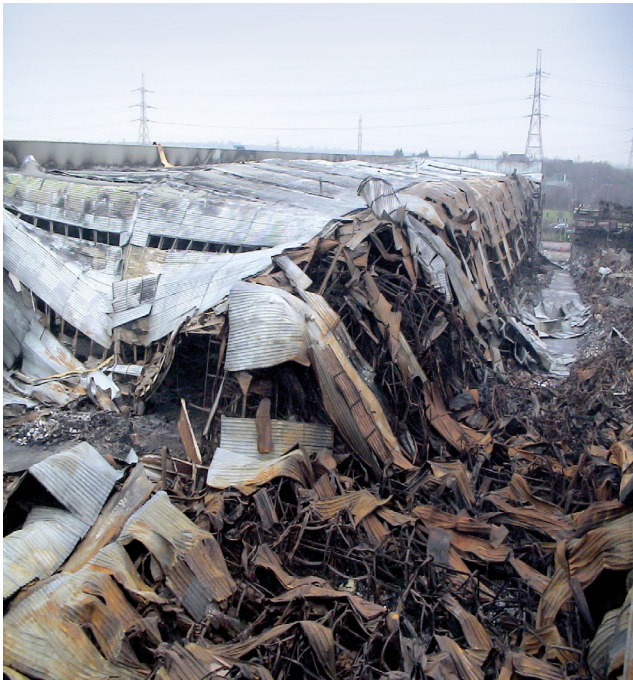
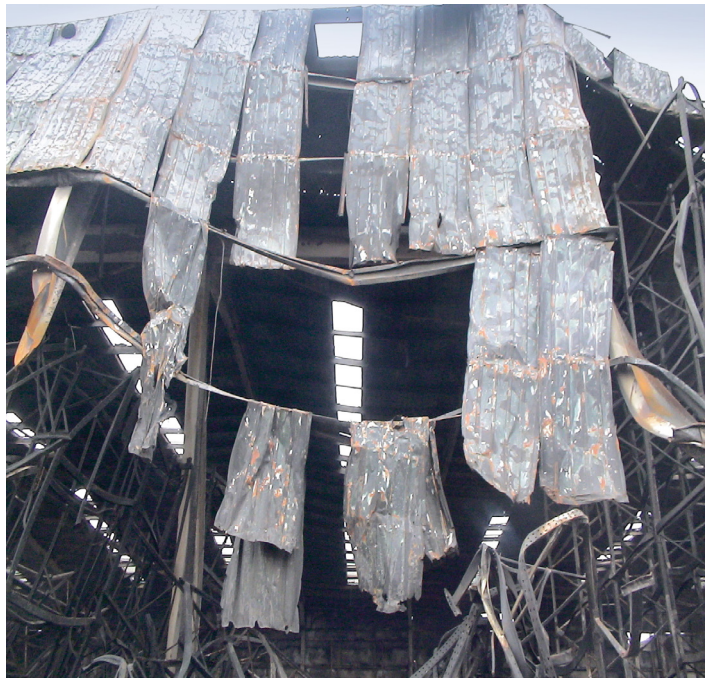
Despite the duration and severity of the fire, significant areas of insulated cladding panels remained with only limited damage to core material indicating that the PIR core material did not promote fire spread.

*Photographs 1 & 2 show the collapsed south-end of the building and roof-sheeting hanging from severely damaged steelwork.*

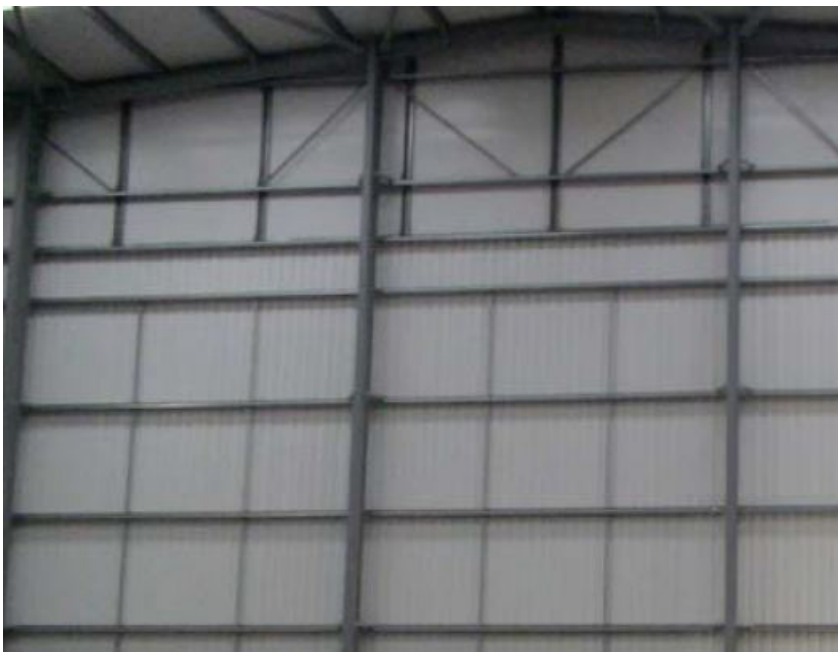
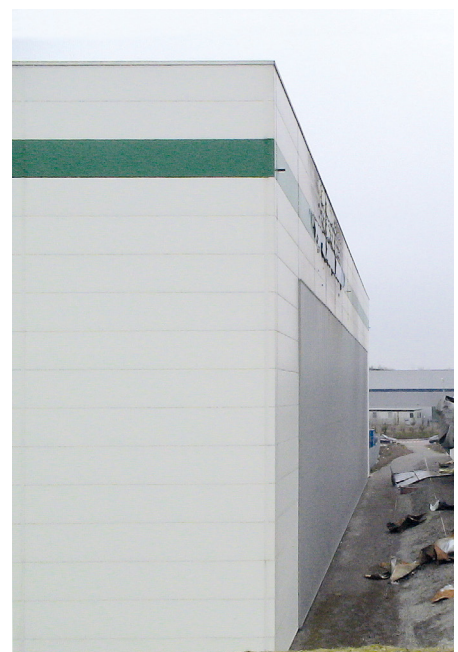
*Photographs 3 & 4 show the undamaged adjacent building (interior and exterior respectively).*

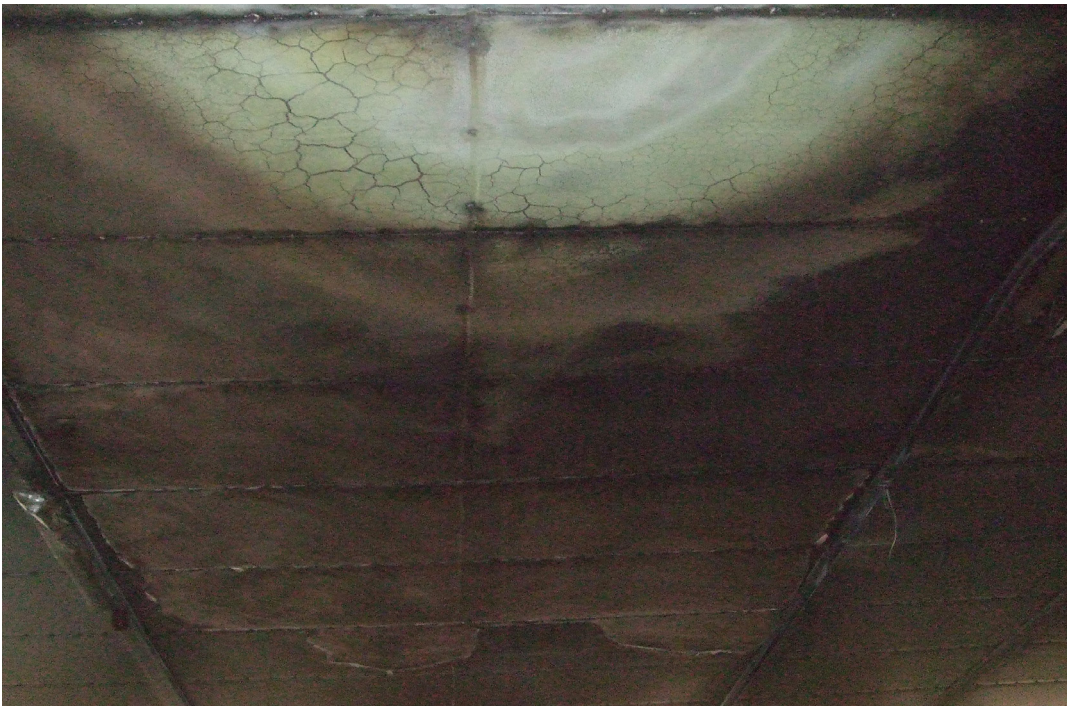
The PIR cored sandwich panels were subjected to a period of fire exposure lasting at least 8 minutes and resulting in a period of sustained flame impingement. The sandwich panels exposed to these conditions sustained damage in terms of removal of the paint coating together with distortion and delamination of the exposed steel skin of the panels away from the PIR core, but the flames did not penetrate the structure, thus maintaining the safety of shoppers and staff.

*Photograph 1 shows the front elevation of the building from the main road and the corner of the building that was closest to the fire location. Photograph 2 shows the flame impact on the soffit lining.*
