This document details independently researched real fire case studies across the world, proving the excellent in-use performance of Insurer Certified PIR panel systems

The Performance of PIR Core Sandwich Panels in Real Fire Situations

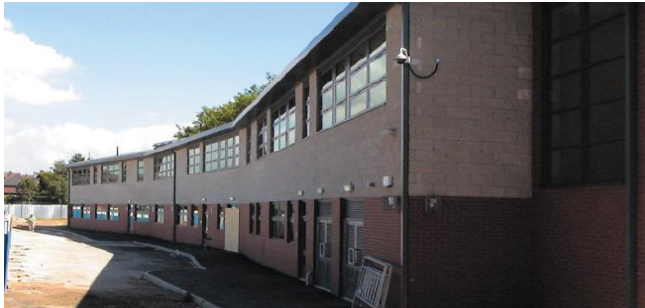
Photograph 1 shows the main school building

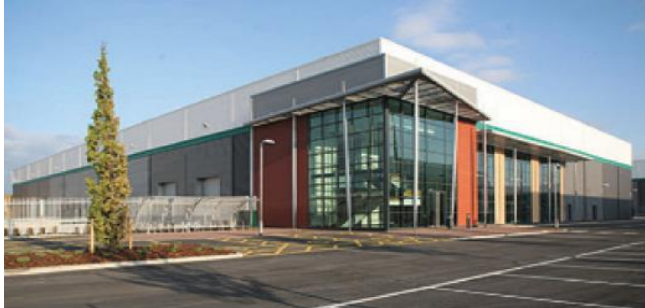
Photograph 1 shows the undamaged exterior of the building

The fire occurred in the first floor men's changing area, containing rows of steel lockers, fitted with clear plastic doors. The fire was confined to a relatively small area but generated a localised severity equivalent to over 30 minutes exposure in a standard fire resistance test.

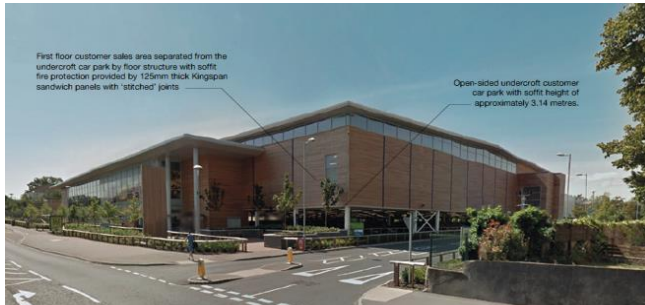
Photograph 1 shows the front elevation of the building from the main road and the corner of the building that was closest to the fire location

The PIR cored sandwich panels were subjected to a period of fire exposure lasting at least 8 minutes and resulting in a period of sustained flame impingement. The sandwich panels exposed to these conditions sustained damage in terms of removal of the paint coating together with distortion and delamination of the exposed steel skin of the panels away from the PIR core, but the flames did not penetrate the structure, thus maintaining the safety of shoppers and staff.
