# Real Fire Case Studies

# THE PERFORMANCE OF PIR CORE SANDWICH PANELS IN REAL FIRE SITUATIONS

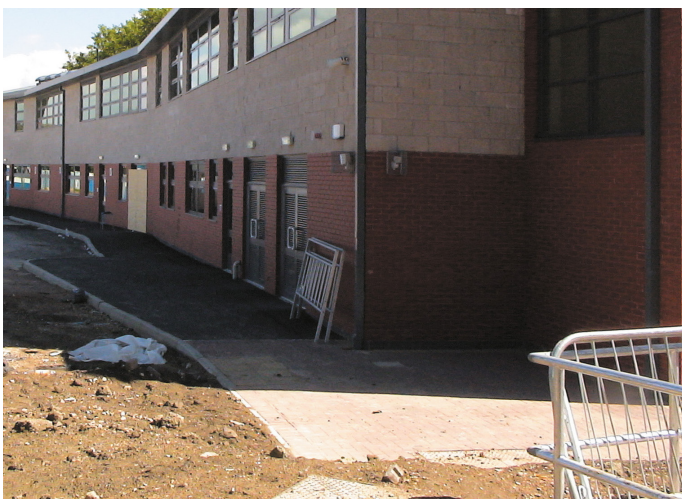
The classrooms were separated from the passageway by compartment walls. The fire did not spread to the classrooms and fire fighters observed only light smoke in some of these rooms. There was no indication of any heat or smoke migration through the insulation of the roofing sheets and the fire service commented that the roofing panels did not contribute to the fire spread.

- The insulated roof panels did not contribute to the cause of the fire
- The insulated roof panels did not contribute to fire spread to any other area of the building and assisted in containing the fire.

*Photograph 1 shows the main school building.*

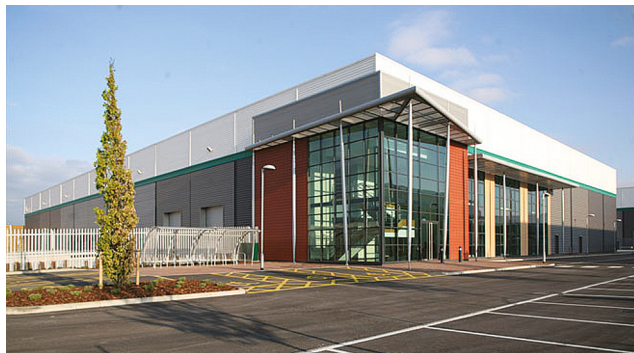
- The sections of the wall panels that were subject to direct contact with the fire suffered surface distortion and superficial charring of the PIR core material. However, there was no evidence of fire propagation within the core material.
- Whilst there was some fire spread beyond the room of the fire origin, this was via the void in the timber floor. The PIR panels provided an effective barrier to fire spread, ie. there was no fire spread through the panels into adjacent areas.

*The photograph to the right shows the undamaged exterior of the building. Photographs 2 & 3 (below) show the cut-open wall panels indicating no fire propagation.*

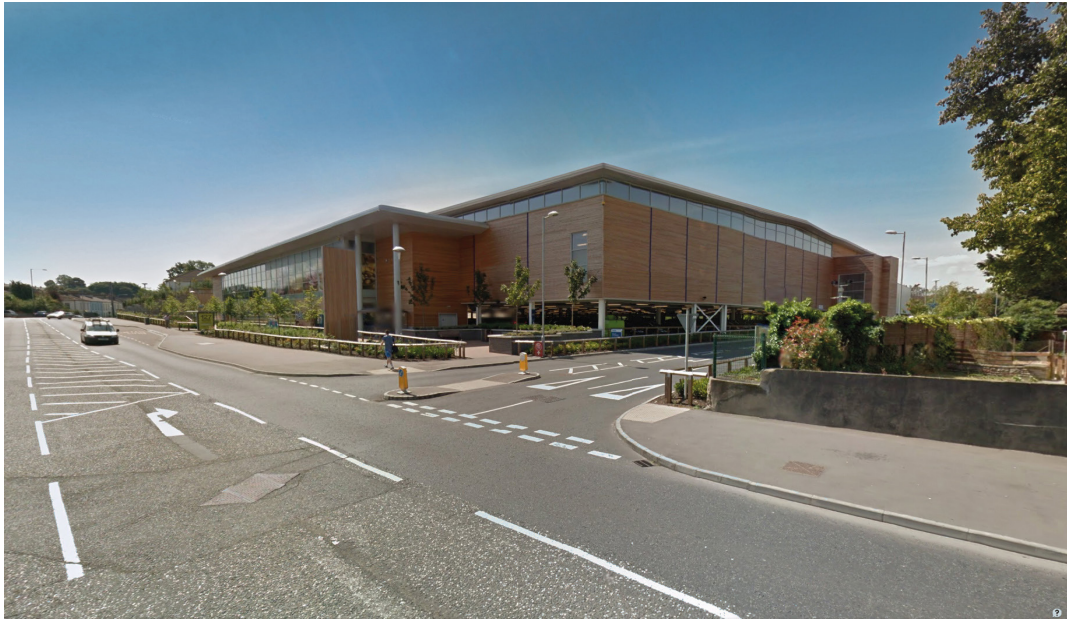
The PIR cored sandwich panels were subjected to a period of fire exposure lasting at least 8 minutes and resulting in a period of sustained flame impingement. The sandwich panels exposed to these conditions sustained damage in terms of removal of the paint coating together with distortion and delamination of the exposed steel skin of the panels away from the PIR core, but the flames did not penetrate the structure, thus maintaining the safety of shoppers and staff.

- The PIR cored sandwich panels were subject to a period of fire exposure lasting at least eight minutes and resulting in a period of sustained flame impingement directly above the fire and gas temperatures to a distance away from the fire sufficient to destroy plastic light fittings.
- The sandwich panels exposed to these conditions sustained damage in terms of removal of the paint coating together with distortion and delamination of the exposed steel skin of the panels away from the PIR core.
- There was no evidence of joints between panels opening up and no PIR core material had been exposed.
- There was no evidence of fire propagation within the panes.

*Photograph 1 shows the front elevation of the building from the main road and the corner of the building that was closest to the fire location. Photograph 2 shows the flame impact on the soffit lining.*
