Insulated panels for external roof and wall cladding

A guide to fire safety and performance in fire

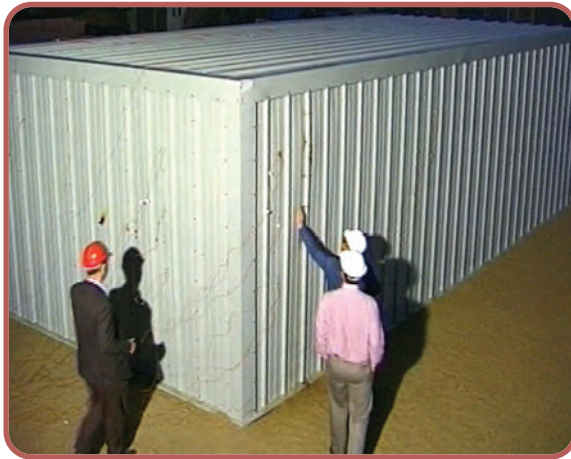
Figure 16. Fully instrumented test building

The LPS 1181 test consists of a room that measures 10 m x 4.5 m x 3 m high (Figure 16) and most importantly assesses panels as they are installed in practice. A heat source comprising a 35kg timber crib to simulate a real fire is placed in the corner of the building (Figure 17) and the room configuration gives rise to a severe test generating 510 KW over the period of the test with a maximum heat output of around 1MW. The crib is placed adjacent to a panel joint. Experience has shown that this configuration seriously challenges the panel and the panel jointing system.

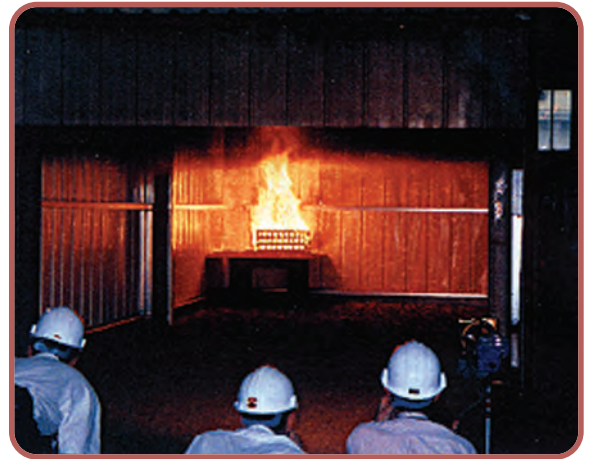
Figure 17. Observation and recording

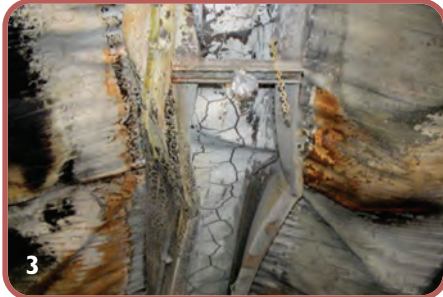
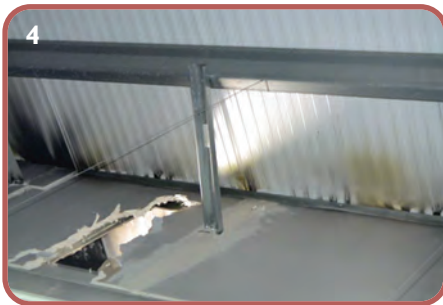
The fire burned fiercely with flames impinging on the left hand blockwork wall, the partition and Insulated Panels above. Flame and hot smoke traveled down the passageway at high level in both directions.

The deformation of the purlins immediately above the seat of the fire shows that this was a very hot fire. The internal faces of eight roof panels in the immediate area of the fire had delaminated and deformed, exposing the insulation.

In spite of the substantial quantity of insulation exposed, there was no evidence that the insulation contributed to the spread of this fire; although it is probable that, while the fire was burning, the insulation charred and some smoke would have been produced.
